TEST CONDUCTED BY:  
Pothole R&D Team

SAMPLE REFERENCE:  
PRD-FT-001

To observe and record the behaviour of the Pothole Relief Device when installed within asphalt and subjected to freeze-thaw conditions.

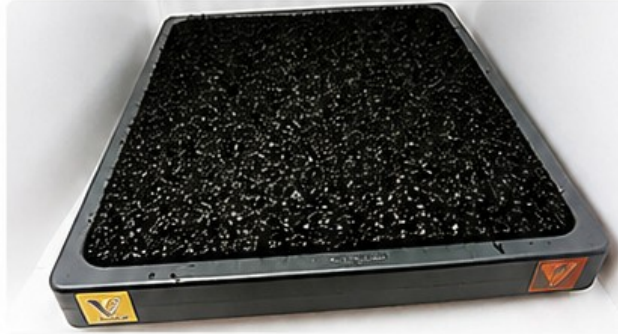
IMAGE 1 – PRIOR TO EXPERIMENT

- Asphalt surface level and intact
- Device installed and not visibly protruding or disturbed
- No visible water displacement at surface

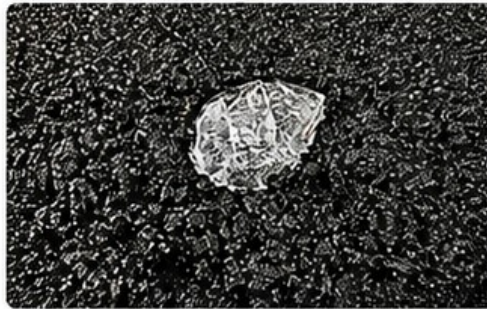
IMAGE 2 – AFTER FREEZE (TOP SURFACE)

- Water expansion observed during freezing process
- Water was forced upward through the Pothole Relief Device
- Water exited via the top of the device and spread across the asphalt surface
- No visible explosive cracking or major displacement of asphalt surrounding the device
- Device remained in position

The device acted as a pathway for expanding water.

Expansion pressure appeared to be relieved vertically, rather than laterally within the asphalt.

Surface water movement indicates controlled release rather than internal stress buildup.
